Western Balkans Environmental Program

Study Tour's Report

Prepared by Dejan Mirakovski
Associated Professor
University "Goce Delcev" -Stip
Faculty of technical and Natural Sciences
Mining department

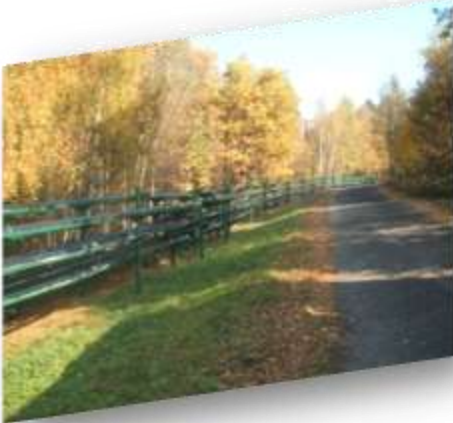
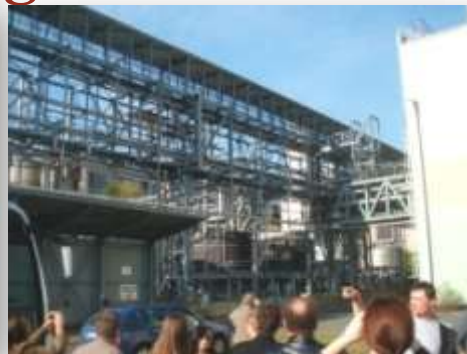
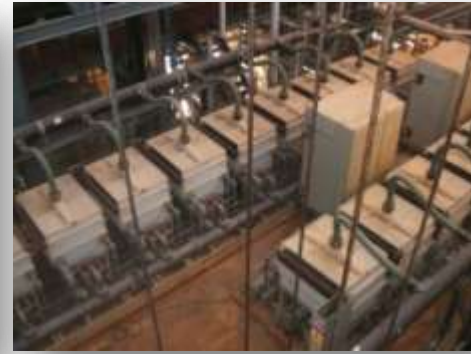
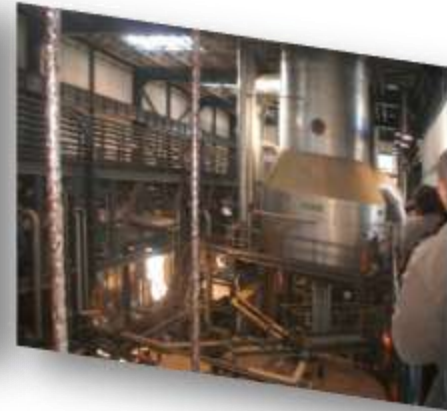
- Sites visited
 - Diamo, s.p. Straz pod Ralskem - former uranium leaching site

Located in North Bohemian plateau former low grade uranium ore leaching operation endanger half of the nation drinking water reserves.

Extensive operations for rehabilitation undertaken. Residues from leaching are pumped and treated in high-tech evaporation plant.

- What we see/learn
 - Uranium leaching site
 - Extensive operation(large scale),
 - High-tech evaporation treatment process used,
 - High costs involved,
 - Good example of how state take care for old environmental burden liquidation!

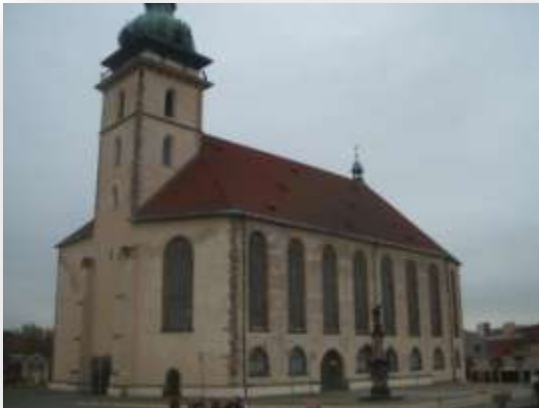
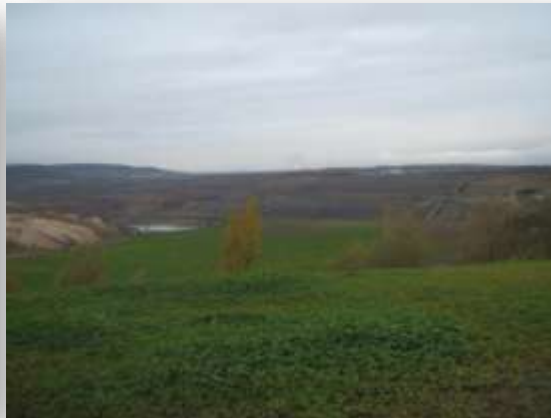
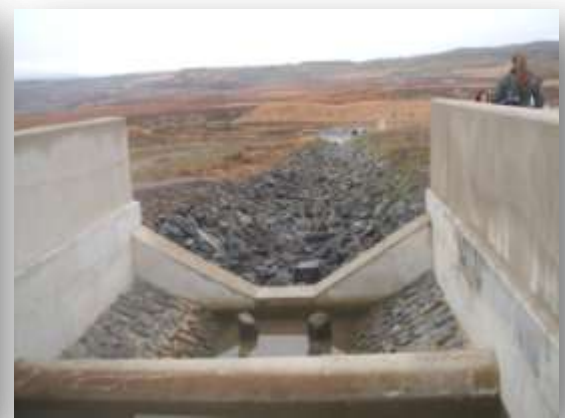
- Sites visited
 - Palivovy kombinat Most – brown coal mining area

Huge brown coal basin with historically very active mining activities. Enormous quantities of earth surface disturbed in more than 100 years history. Extensive rehab operation undertaken with governmental funding. Even the old city Most was more or less ruined as a result of land sliding and surface subsidence.

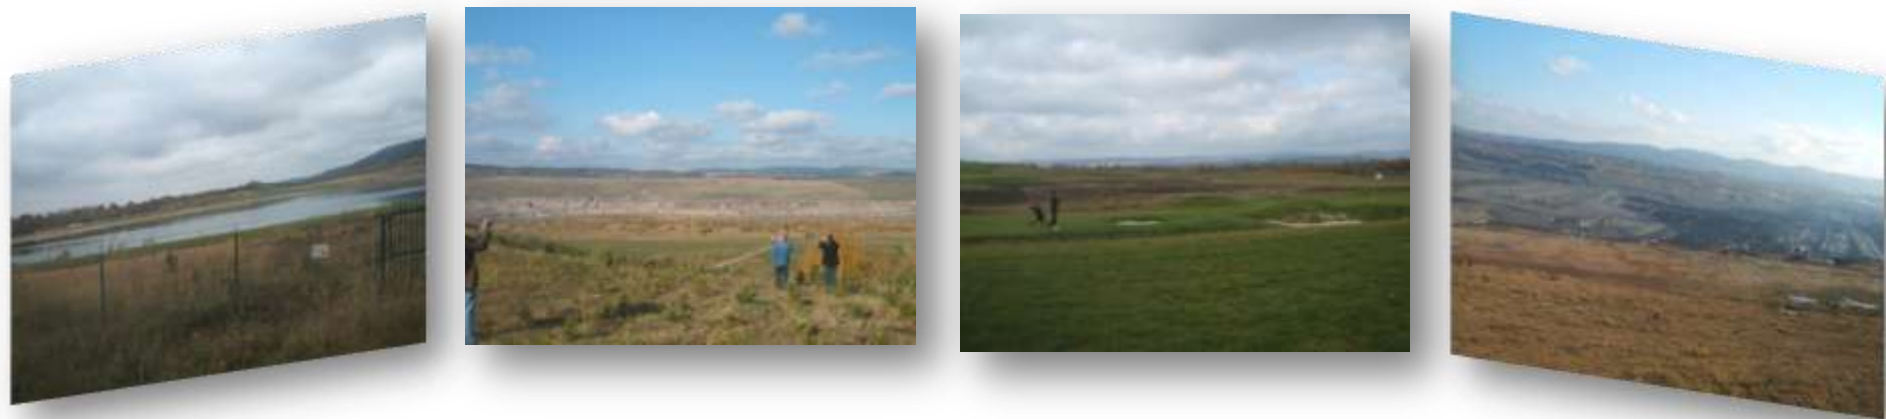
- Sites visited
 - Sokolovska uhelna, a.s. Sokol- brown coal mining area

One of the biggest country coal producing regions (10 M t brown coal/year), 620 MW power plants and extensive coal processing (gasification, briquettes, chemicals...)
Total area for reclamation 9.259,48 ha of what 33,22 % reclaimed, 27,8 under construction and 38,98 % to be reclaimed.

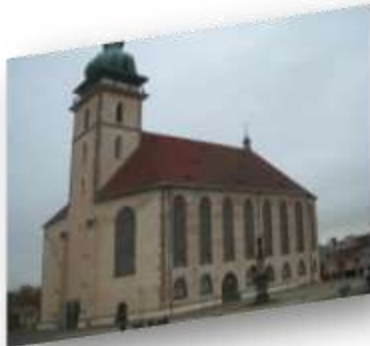
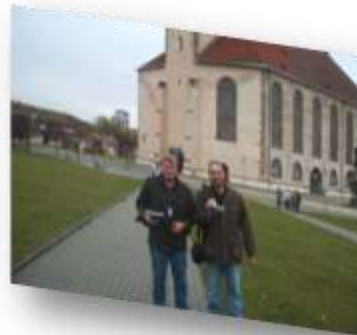
- What we see/learn
 - Most – brown coal site
 - Interesting relocation of cathedral (about 300 m of original location in one piece).
 - Rehabilitation in final phase, facilities for recreation and lakes under construction.
 - All works funded by government.

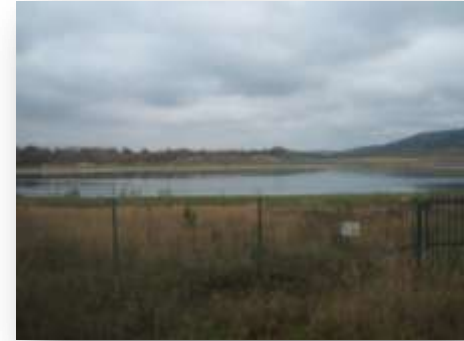
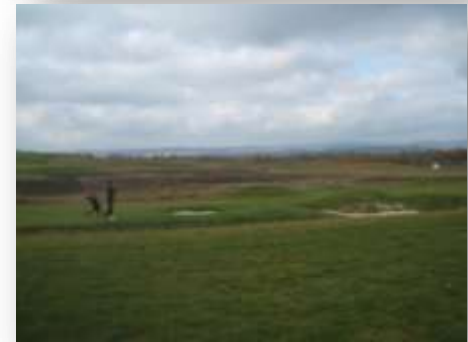
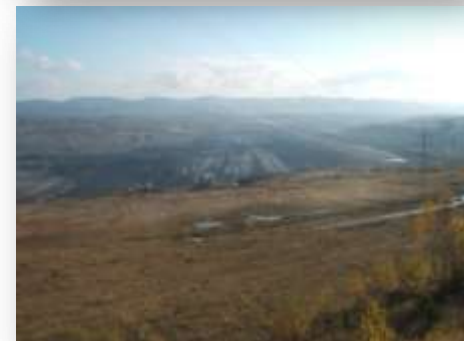
- What we see/learn
 - Sokol – brown coal site
 - Excellent synchronization of rehabilitation activities,
 - Old area funded by government, new by the mining company,
 - Interesting ideas for after mining land usage (water recreation park, golf court, large water bodies).

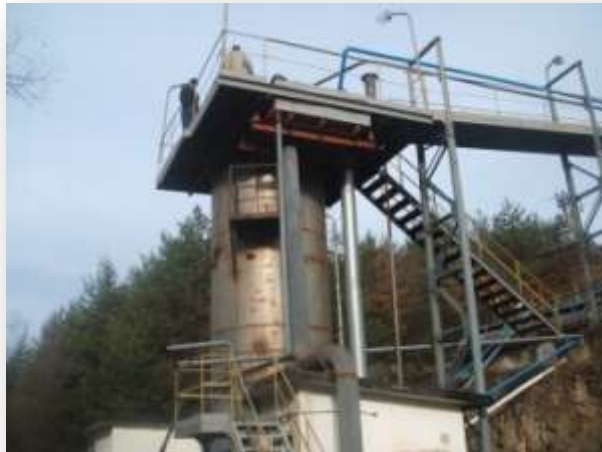
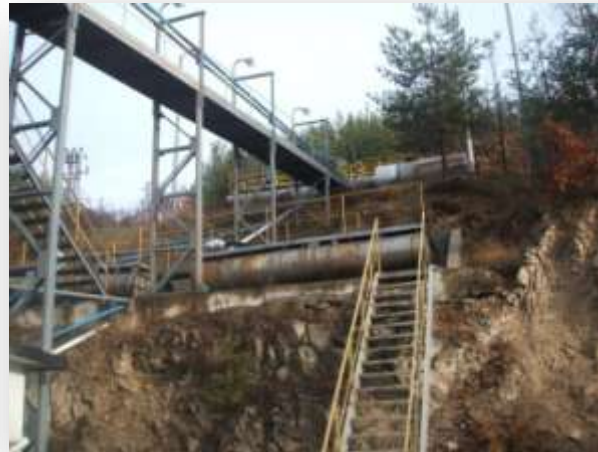
- Sites visited
 - Belata voda

Former low grade uranium mine in Central Bulgaria where mine waters endanger Martisa one of the country biggest watercourse.

Small, simple, efficient and low costs treatment (sorption) plant was designed to treat up to 2000 m³ mine waters per 24 h.

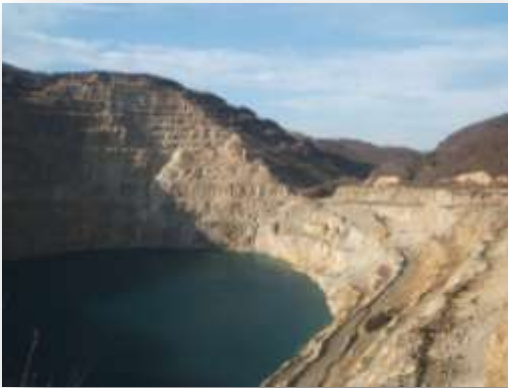
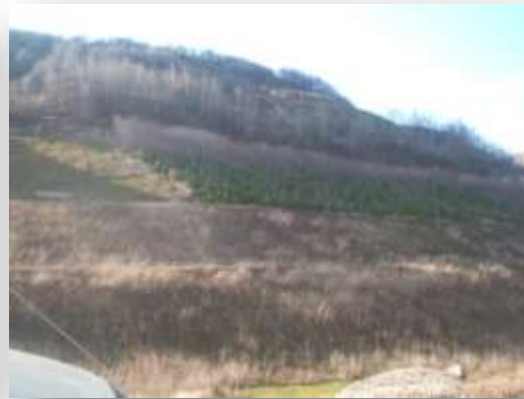
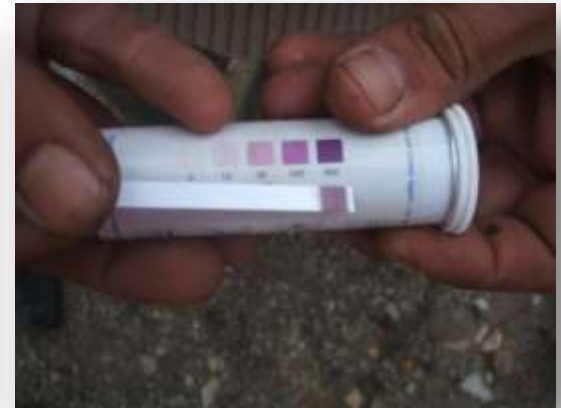
- Sites visited
 - Medet -Panajuriste

Biggest polymetallic formation in Balkan's (+ 20 mines in 40 x 40 km area). At former Medet Cu mine more than 200 M m³ rocks were excavated. Huge (>100 M m³ disposed at waste rocks dumps).

Reclamation under state funding started and in final phase. Two large Mines still active in the area funding their own reclamation activities!

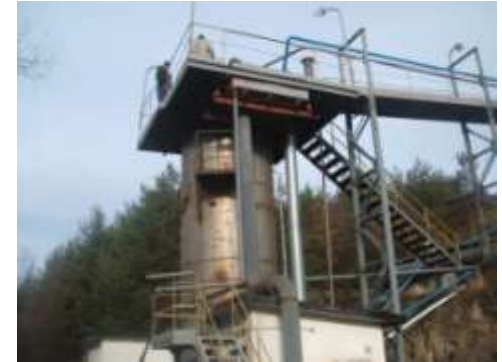
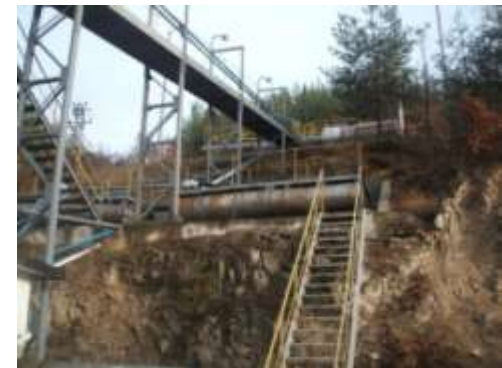
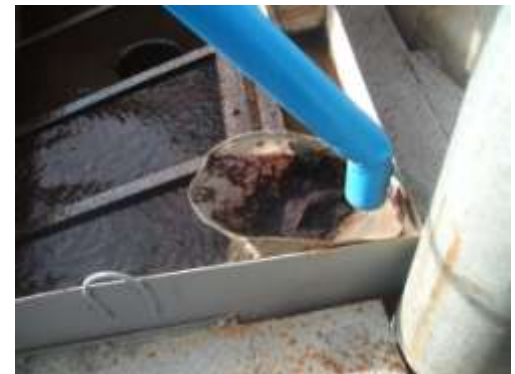
- What we see/learn
 - Sorption plant Belata Voda
 - Very small and efficient treatment plant for 2000 m³ /day.
 - More than 99 % efficiency and meets all regulatory standards for effluent water.
 - In operation more than 9 year with minimal costs and only small maintenance works.
 - Never have larger breakdown.
 - Total costs 8000 Euros /month!
 - From sorption resin yellow cake is produced as potentially commercial product.

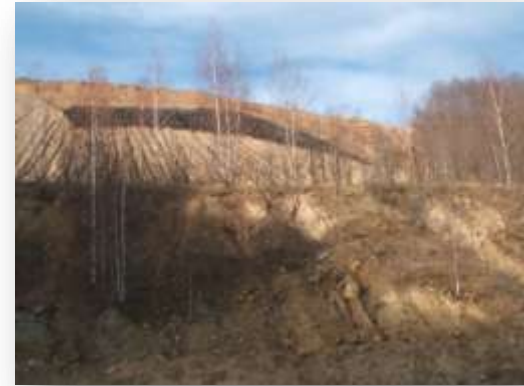
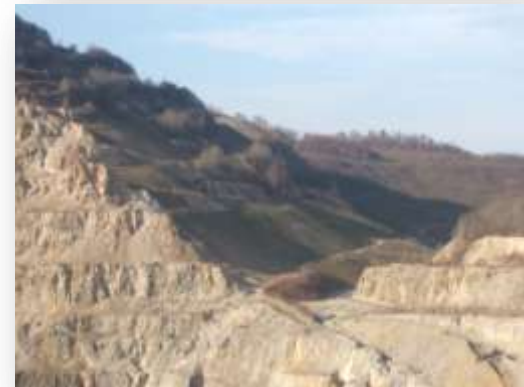
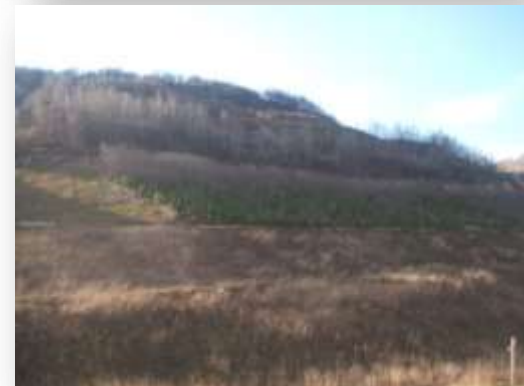
- What we see/learn
 - Medet former mine site
 - Extensive rehabilitation activities on waste rock dumps including
 - Reshaping and stabilization
 - Revegetation
 - Drainage waters collection channels under construction.
 - Treatment plan under construction.
